PA-479 DAM

NDI I.D. NO: PA-509

PHASE I INSPECTION REPORT
NATIONAL DAM INSPECTION PROGRAM

✓ D'APPOLONIA CONSULTING ENGINEERS
10 DUFF ROAD
PITTSBURGH, PA. 15235
MARCH 1979

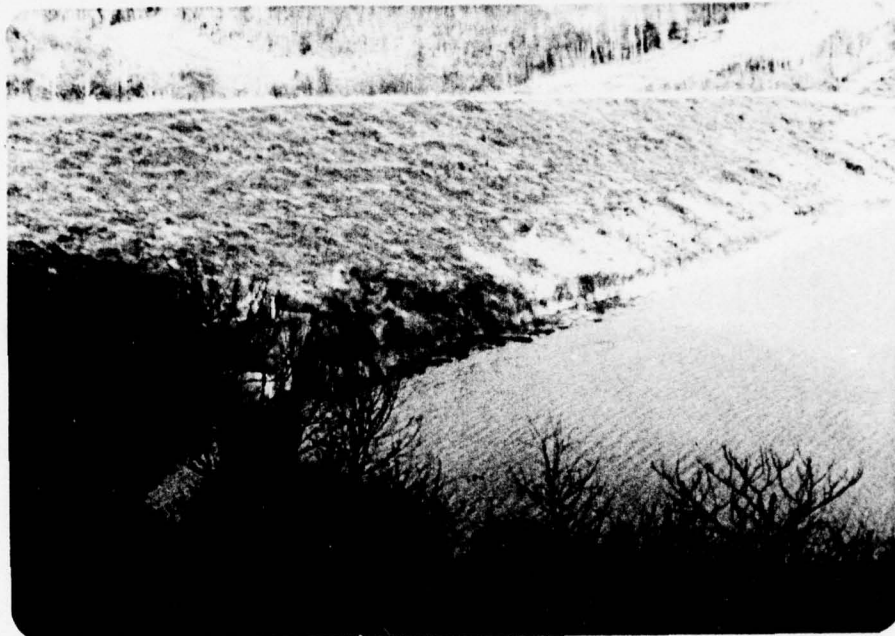
Upstream Face

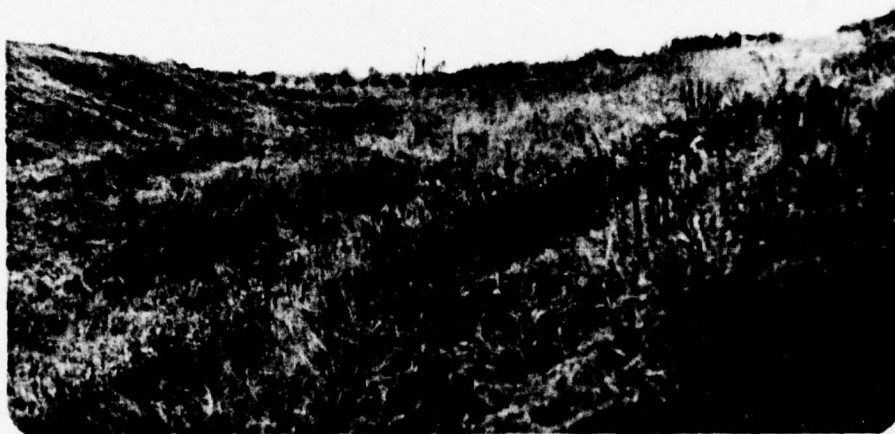
Photograph No. 1
Emergency spillway approach channel.

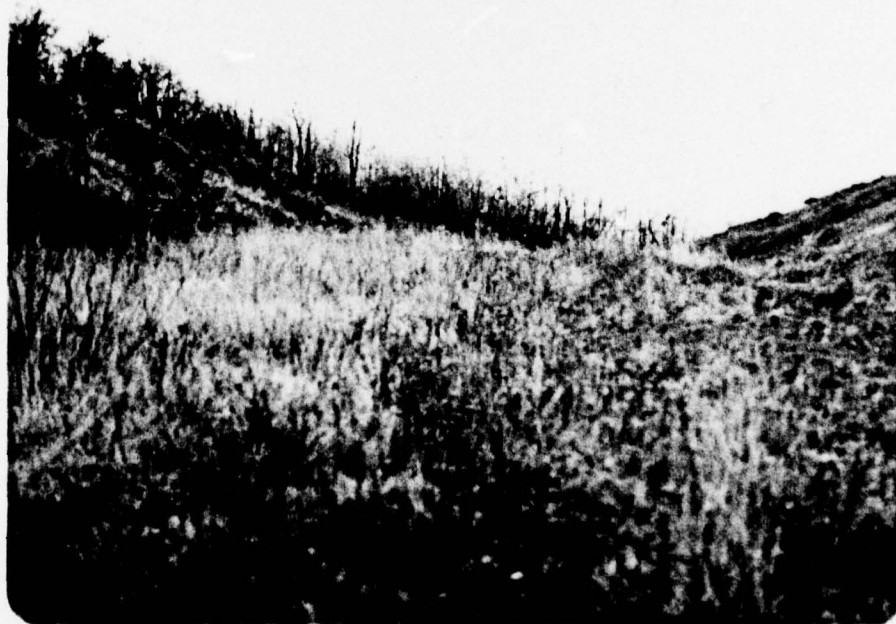
c. Visual Observations. As observed during the inspection and as reported from previous investigations, the potential exists for the emergency spillway to be blocked (completely or partially) by a slope failure above the spillway. Such a failure would be more likely to occur during heavy rainfall conditions requiring discharge through the spillway.

Photograph No. 2
Emergency spillway discharge channel.

1. The slope adjacent to the emergency spillway should be stabilized to prevent development of a slide which would block the spillway.
2. The wet area located on the downstream slope should be periodically observed to document if a seepage condition is developing. Necessary remedial work should be performed if such conditions develop.
3. An around-the-clock surveillance should be provided during unusually heavy runoff and

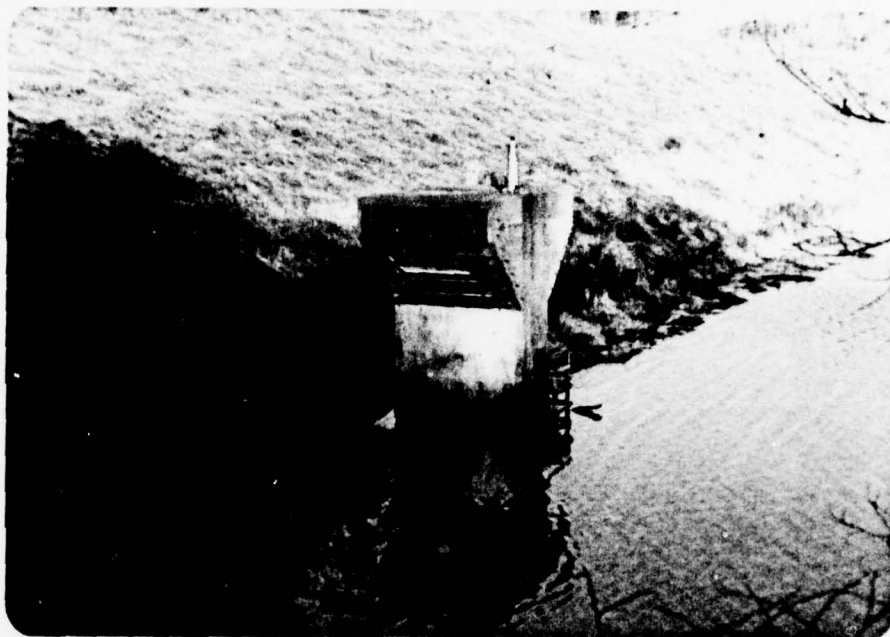
Photograph No. 3
Primary spillway drop inlet structure.

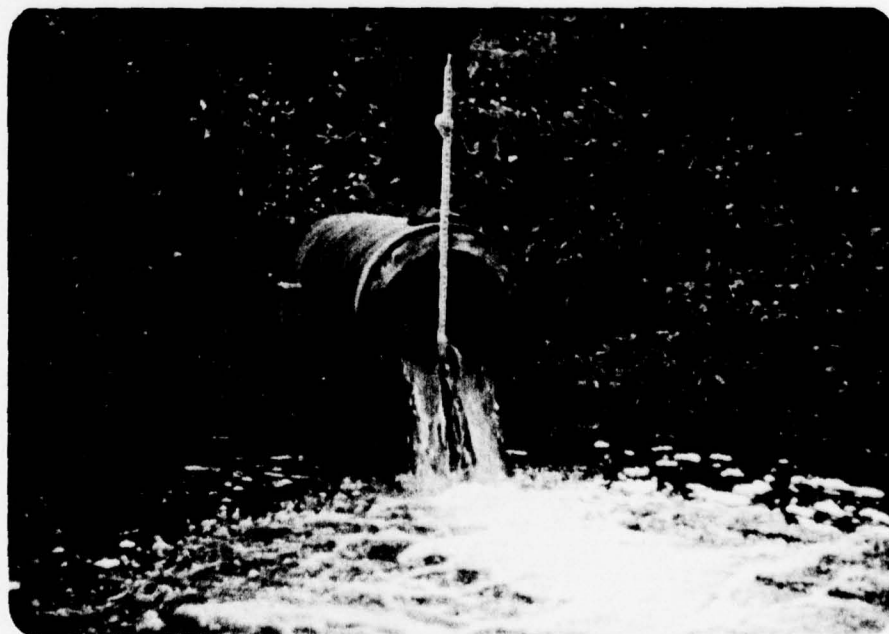
Photograph No. 4
Outlet pipe.
